### Property Condition Report: Introduction

The HouseCheck Property Condition Report is designed for property owners and prospective buyers seeking a comprehensive assessment of defects identified by the HouseCheck inspector. This report encompasses both "Material Defects" and "Minor or Cosmetic imperfections" that require attention to restore the property to its optimal state. With reference to compliance under South Africa's National Building Regulations and the South African National Standards (SANS) 10400.

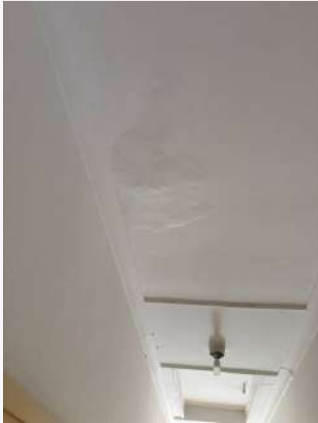
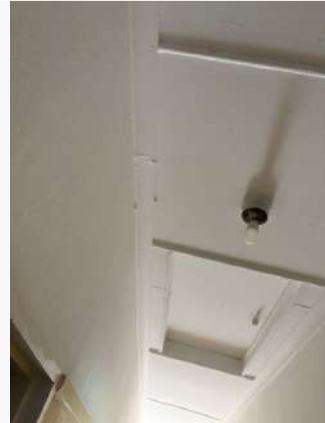
| Ref | Item | Description | Defects Observed | Action Recommended |
|---|---|---|---|---|
| 3.1 | Ceiling | Gypsum ceiling | <p>Crack on in the ceiling.</p> <p>MATERIAL DEFECTS - Carpenter</p> | Repairs recommended |

Ref #3.1 - Cracks observed

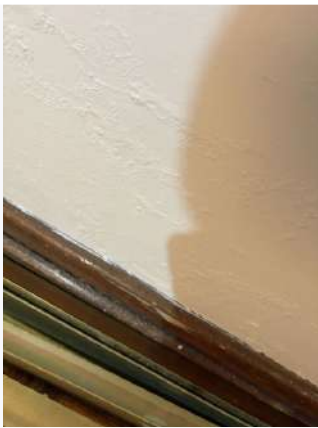
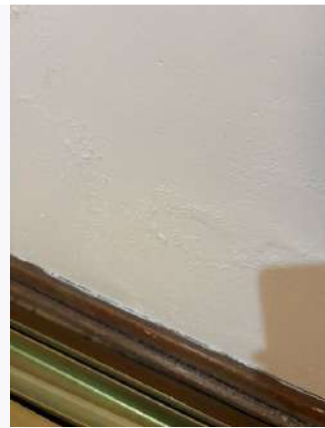
| Ref | Item | Description | Defects Observed | Action Recommended |
|---|---|---|---|---|
| 3.2 | Walls | Plastered and painted | <p>Rising dampness observed, this is due to water penetrating the foundation as detailed in the grounds section of this report.</p> <p>MAINTENANCE - Painter</p> | Repairs recommended |

Ref #3.2 - Mold on walls

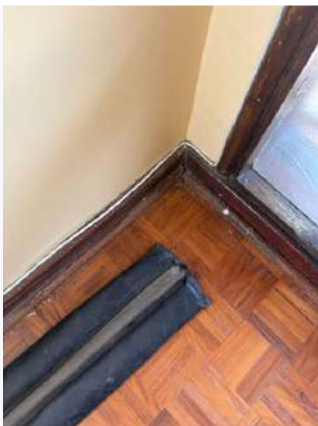
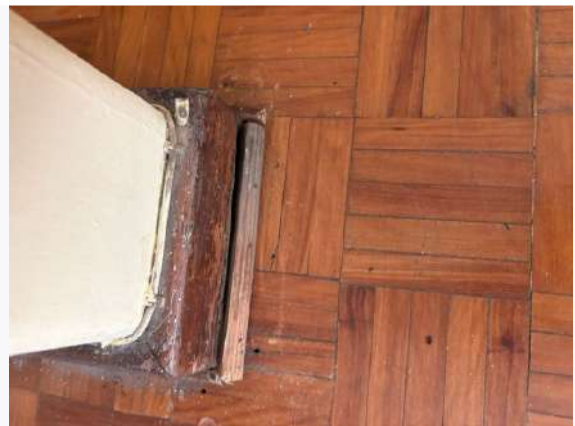
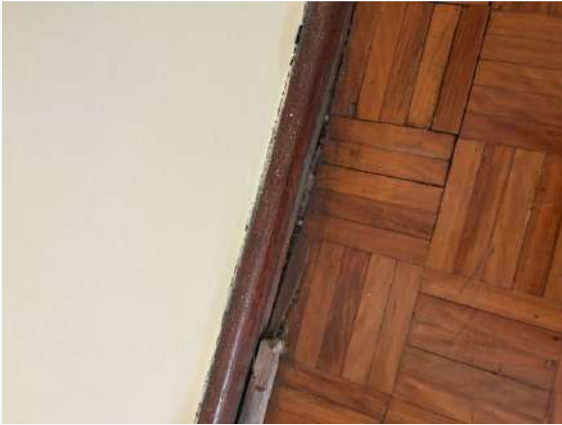
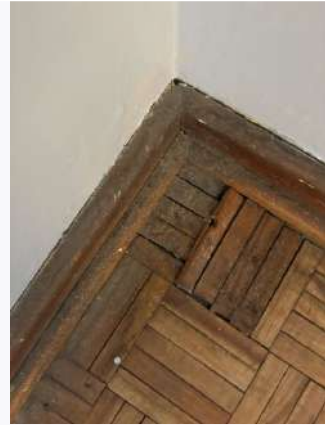
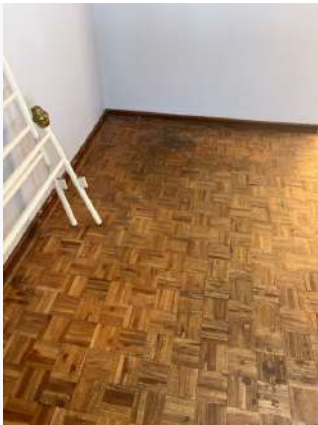
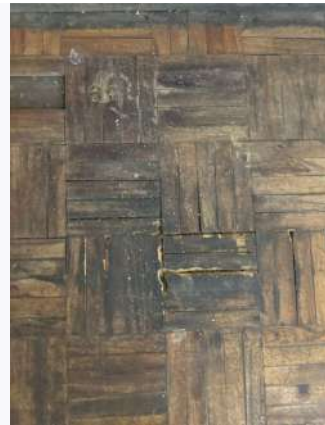
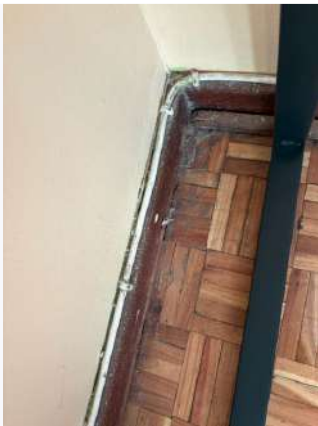
| Ref | Item | Description | Defects Observed | Action Recommended |
|---|---|---|---|---|
| 3.3 | Floors | Solid teak wood interlocking flooring tiles | <p>The wooden floor was damaged severely ,although there are methods to restore the wood, which includes professional sanding, the amount of damage of the wood would require replacement of the board as there is significant damage.</p> <p>MAINTENANCE - Carpenter</p> | No action recommended |

Ref #3.3 - Lounge floor with wood damage

Ref #3.3 - Bedroom 1 floors with wood damage

Ref #3.3 - Bedroom 3 floor with wood damage

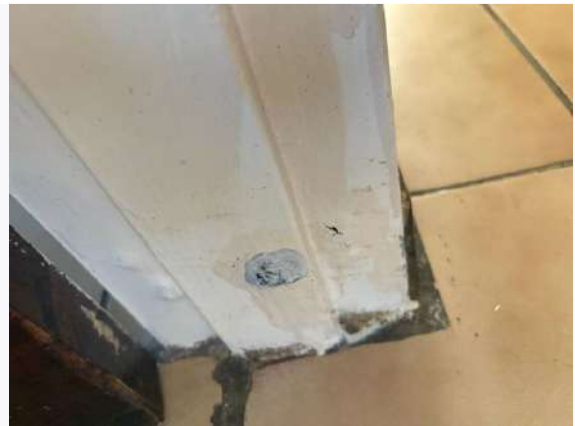
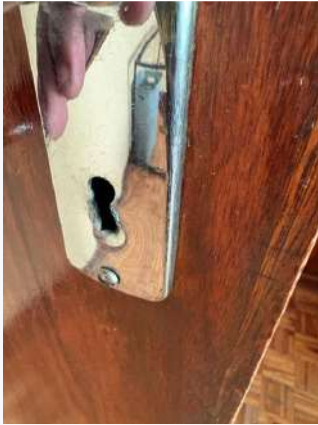
| Ref | Item | Description | Defects Observed | Action Recommended |
|---|---|---|---|---|
| 3.4 | Doors (Interiors) | Wooden door | <p>-Door lock appeared to be in bad condition</p> <p>-Steel door frame metal door frame rusted</p> <p>MATERIAL DEFECTS - Carpenter MAINTENANCE - Painter</p> | No action recommended |

Ref #3.4 - Door frame corroded

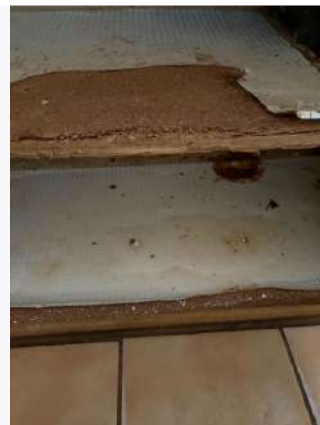
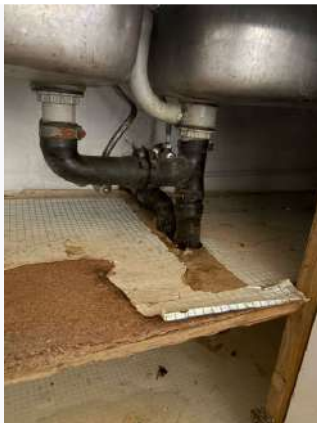
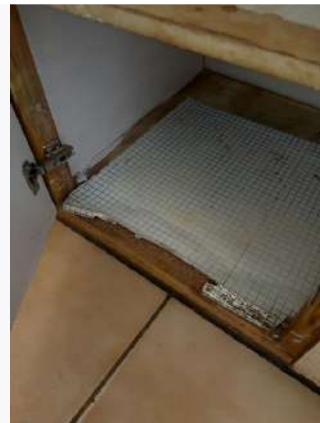
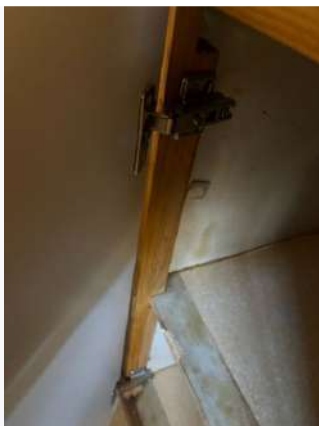
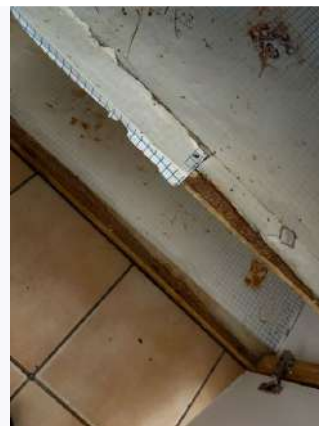
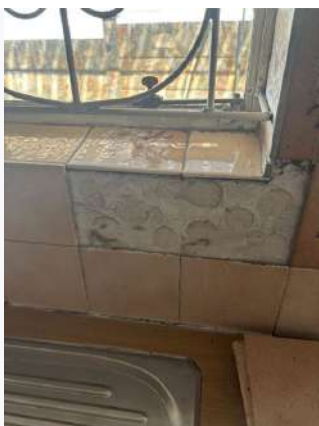
| Ref | Item | Description | Defects Observed | Action Recommended |
|---|---|---|---|---|
| 5.2 | Cupboards | Cupboard - Wood | Significant damage to cupboard(s) , replacement recommended<br>MATERIAL DEFECTS - Carpenter | Replacement recommended |

Ref #5.2 - Significant damage to cupboards

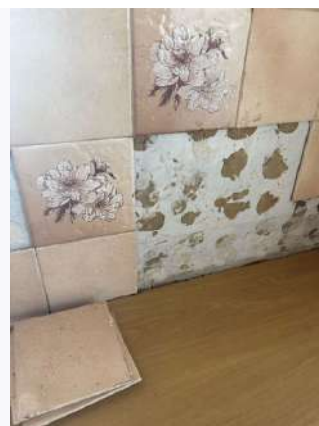
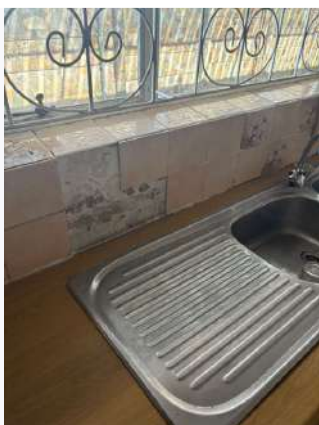
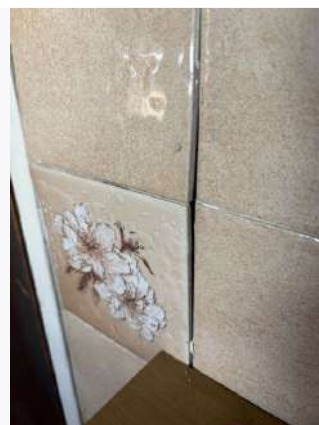
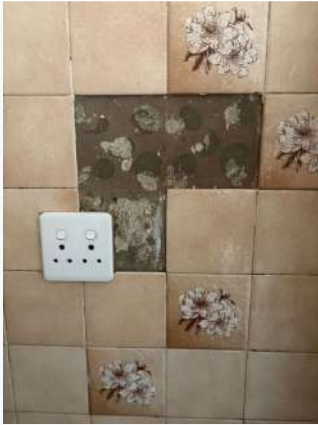
| Ref | Item | Description | Defects Observed | Action Recommended |
|---|---|---|---|---|
| 5.6 | Walls | Tiled walls | -The wall tiles were debonding from the wall in some sections .<br>- There were some tiles missing on the wall , this is due to poor installation. | No action recommended |

Ref #5.6 - Missing tiles

Ref #5.6 - Damaged tiles

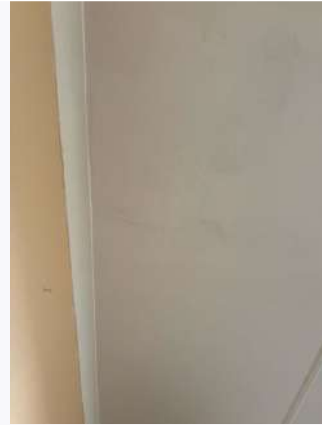
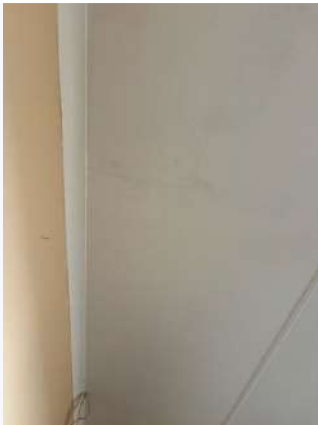
| Ref | Item | Description | Defects Observed | Action Recommended |
|---|---|---|---|---|
| 5.7 | Ceiling | Gypsum ceiling | Crack observed in some sections of the ceiling structure. It is advisable to replacements the entire ceiling to mitigate the risk of further damage.<br>MATERIAL DEFECTS - Carpenter | Replacement recommended |

Ref #5.7 - Cracks on ceiling

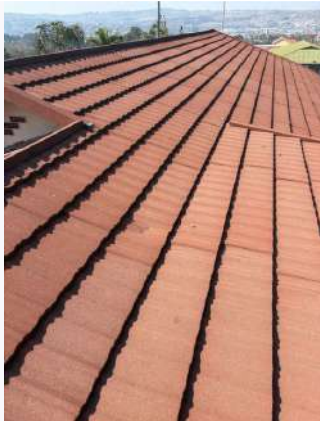
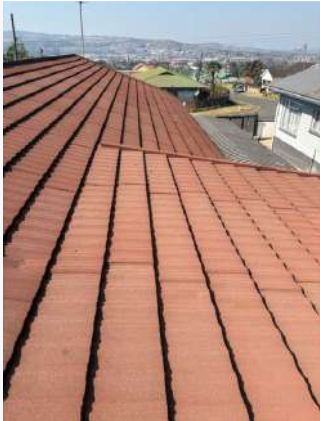
| 7. ROOF EXTERIORS | | | | MAIN STRUCTURE |
|---|---|---|---|---|
| 7.1 | Roof covering | Metal roof tiles | Some tiles exhibited sign of damage and misalignment, this can lead to water penetrating the roof cavity and cause extensive damage to the ceilings and walls<br>MATERIAL DEFECTS - Roofing Specialist | Replacement recommended |

Ref #7.1 - Misaligned /damaged tiles

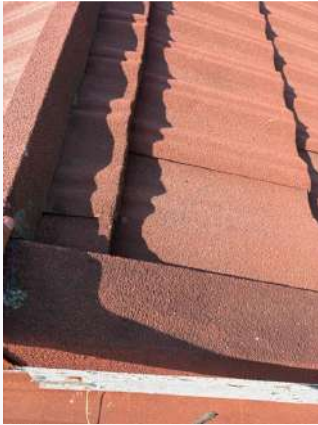
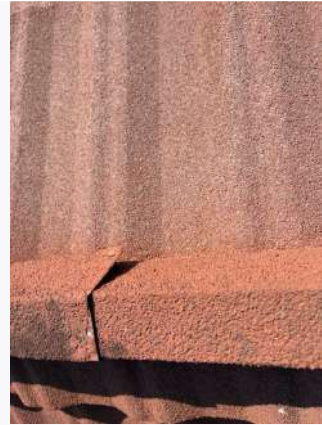
| 7. ROOF EXTERIORS | | | | MAIN STRUCTURE |
|---|---|---|---|---|
| 7.2 | Ridges | Metal | Ridge capping damaged in places , water penetrating is likely.<br>MATERIAL DEFECTS - Roofing Specialist | Repairs recommended |

*Ref #7.2 - Ridge capping damaged*

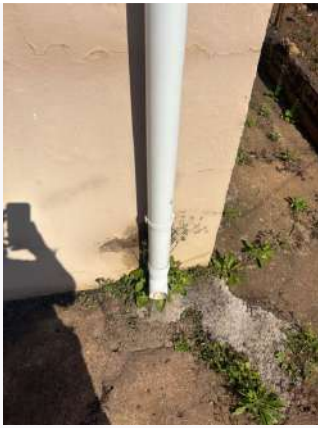
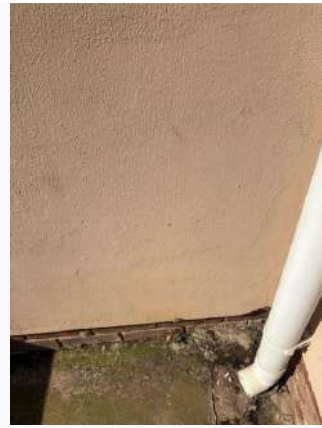
| 7. ROOF EXTERIORS | | | | MAIN STRUCTURE |
|---|---|---|---|---|
| 7.4 | Gutters & Downpipes | Asbestos downpipes<br>asbestos gutters<br>,PVC Gutters | 1. Some downpipes were discharging on unprotected soil at the base of a wall .<br>2.Gutter system infested with debris<br>MAINTENANCE - Handyman | Maintenance recommended,<br>Repairs recommended |

*Ref #7.4 - Gutter discharging on unprotected grounds*

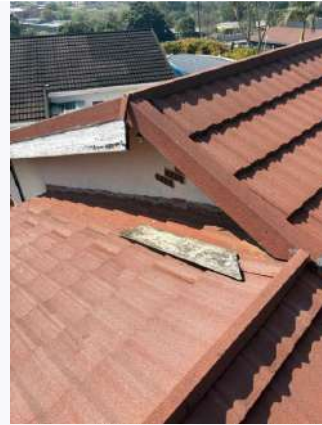
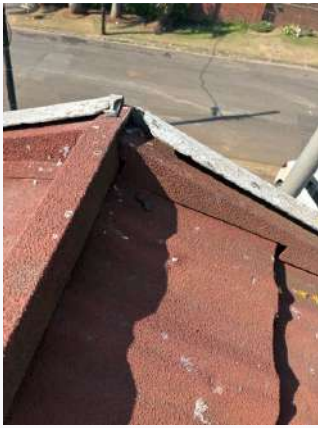
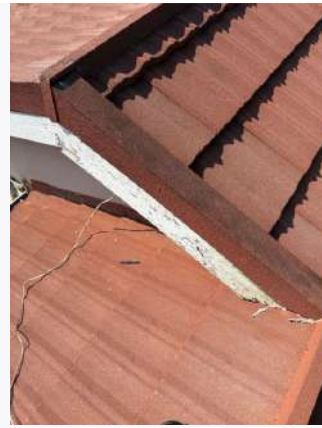
| 7. ROOF EXTERIORS | | | | MAIN STRUCTURE |
|---|---|---|---|---|
| 7.5 | Fascias | Fibre cement /timber | Timber fascia boards rotten in places and beyond repair<br>MATERIAL DEFECTS - Roofing Specialist | Replacement recommended |

Ref #7.5 - Damaged fascia

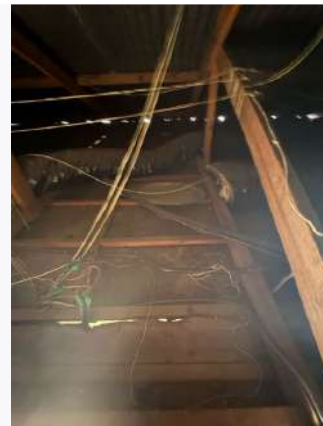
| 8. ROOF CAVITIES (CONT.) | | | | |
|---|---|---|---|---|
| 8.8 | Electrical installation wiring in roof cavity | Some electrical wiring not protected by conduits | <p>Some electrical wiring lying loose and is dangerous , this should be covered by the electrical COC:</p> <p>NB:</p> <p>Home inspectors do not test the electrical installation of a house because the home inspector is not a licensed electrician. Likewise the home inspector does not issue a certificate of compliance (CoC) for the installation. This is a document which is required by law in South Africa, every time a property is sold (transferred) and every time an electrical installation is altered. In South Africa it is the seller responsibility for the issue of the electrical CoC.</p> <p>The Occupational Safety Act (85) of 1993 (updated 2008) requires that all house electrical installations must be installed and repaired under control of a registered electrician. The Act also stipulates that the property owner must be in possession of a certificate of compliance for any changes to the wiring of the property</p> <p><b>MATERIAL DEFECTS - Registered Electrician</b></p> | Specialist review recommended |

Ref #8.8 - Exposed wiring

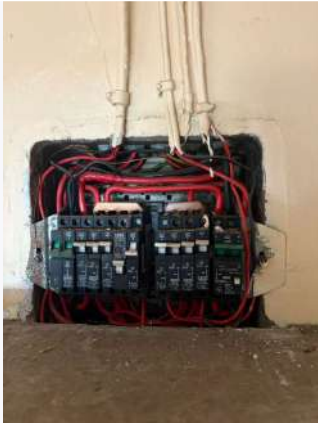
| Ref | Item | Description | Defects Observed | Action Recommended |
|---|---|---|---|---|
| 10.1 | Electrical - Main DB board | Located in the kitchen | <p>The distribution board was visually inspected, compliance was not verified ,it is advisable to engage a register electrician to assess the installation.</p> <p><b>MATERIAL DEFECTS - Registered Electrician</b></p> | Specialist attention recommended |

Ref #10.1 - Electrical distribution board

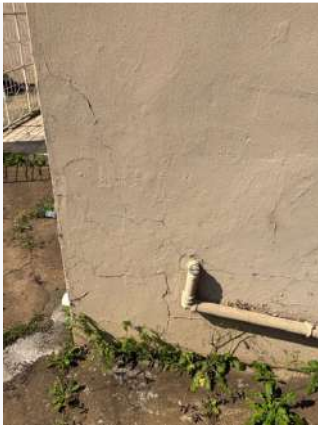
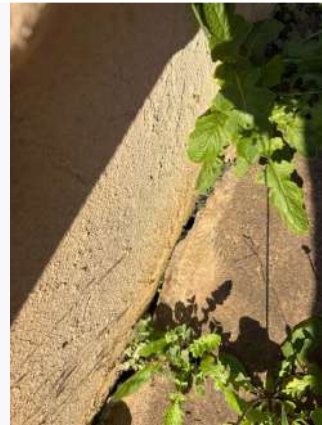
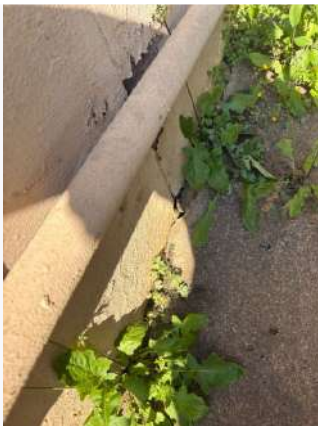
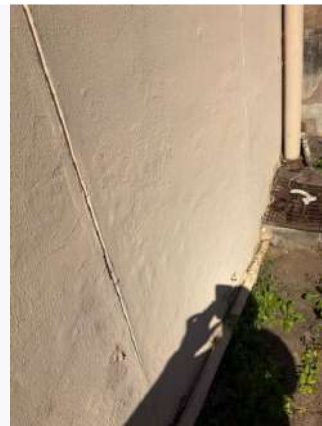
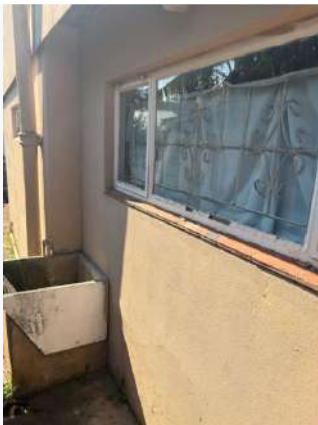
| Ref | Item | Description | Defects Observed | Action Recommended |
|---|---|---|---|---|
| 11.1 | Exterior walls | Plastered and painted | <p>-Rising damp observed in some sections of the wall , this is a result of poor stormwater management in the property ,</p> <p>- minor settlement crack were observed in the walls ,the cracks were measured to be less than 4mm and required redecoration.</p> <p><b>MATERIAL DEFECTS - Painter</b></p> | Repairs recommended |

Ref #11.1 - Wall with minor cracks

Ref #11.1 - Mold observed on walls

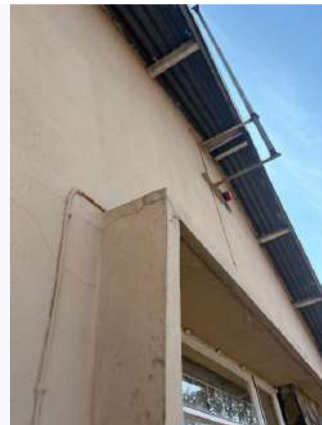
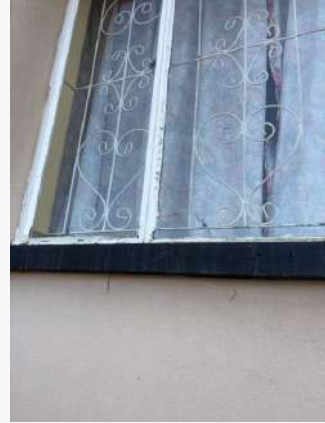
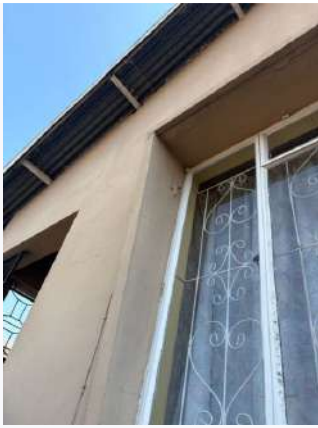
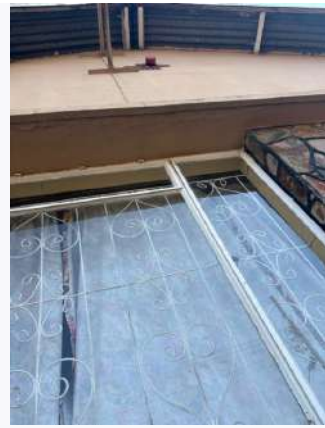
| MATERIAL DEFECTS | | | |
|---|---|---|---|
| <a href="#">11.2</a> Superstructure » Windows (Exteriors) | -Glazing putty was cracked/damaged in some areas .<br>-Concrete overhang with significant damage, this is due to lack of waterproofing at the top of the window overhang, this allows significant amount of water to penetrate the structure which the causes mold. | Damp Proofing Specialist | R 4,000.00 |

Ref #11.2 - Mold on wall

Ref #11.2 - Damaged putty

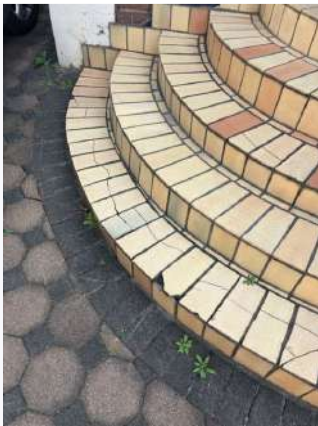
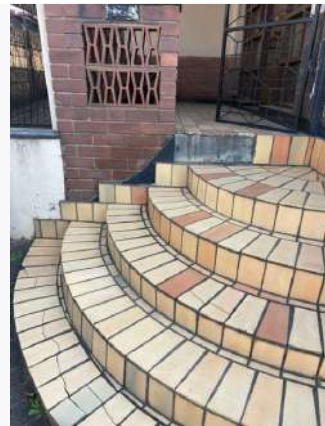
| MATERIAL DEFECTS | | | |
|---|---|---|---|
| <a href="#">11.3</a> Superstructure » Stairways - exterior | Damaged tiles on the stairway tread | Tiler | R 5,000.00 |

Ref #11.3 - Damaged tiles

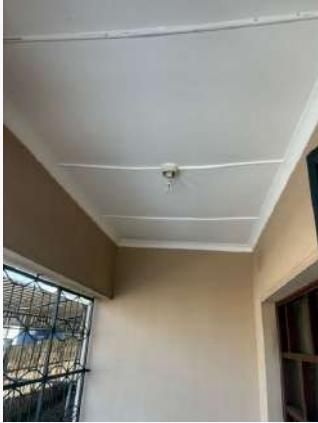
| MATERIAL DEFECTS | | | |
|---|---|---|---|
| <a href="#">11.4</a> Superstructure » Porch | Porch ceiling was sagging severely and requires urgent replacement. | Carpenter | R 10,000.00 |

Ref #11.4 - Sagging ceiling

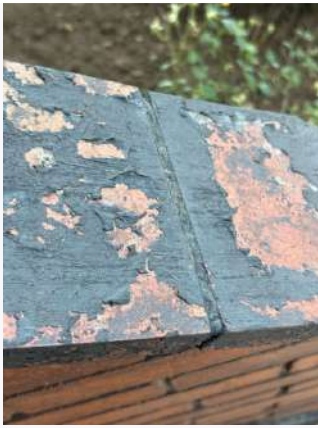
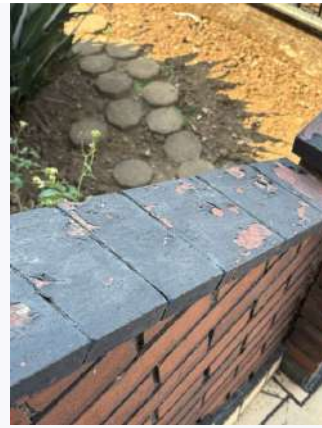
| MATERIAL DEFECTS | | | |
|---|---|---|---|
| <a href="#">11.5</a> Superstructure » Balustrades & Handrails | The capping of the handrails exhibited signs of excessive waterproofing deterioration , this is a significant issue because it can tantamount to water ingress into the main stairway structure which then affects the structural integrity of the structure. | Damp Proofing Specialist | R 2,500.00 |

Ref #11.5 - Damaged capping

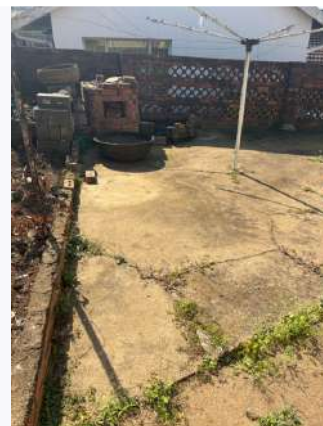
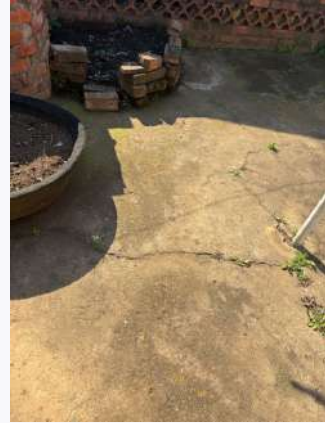
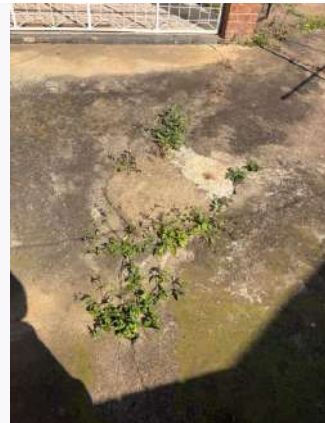
| MAINTENANCE | | | |
|---|---|---|---|
| <a href="#">12.1</a> Grounds » Stormwater management | Ground subsiding in places, this is due to poor stormwater management. This is a major issue because it can lead to soil erosion which tantamount to flooding.<br>- A non-functional stormwater management systems allows excessive volume of water to penetrate the foundations which constitutes to structural instability a rising / penetrating damp.<br>-Ponding of groundwater runoff was evident in the back section of the property this is due to an inadequate stormwater management systems and/or grading of the ground levels away from the superstructure.<br>-Downpipes were discharging onto unprotected soil at the base of the wall ,Downpipe requires a drain or concrete channel system to lead water away from the structure | Landscaping Specialist | |

Ref #12.1 - Evidence of water ponding/Ground subsiding

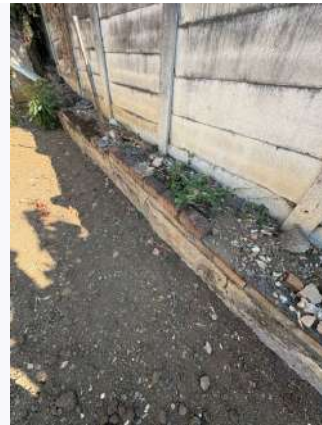
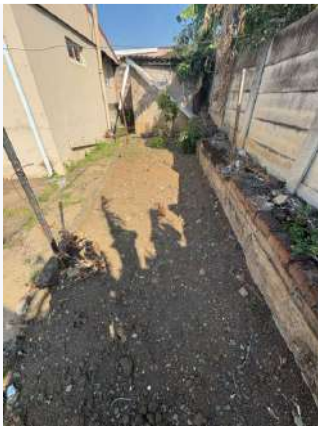
| MATERIAL DEFECTS | | | |
|---|---|---|---|
| <a href="#">12.4</a> Grounds » Boundary walls | Evidence of foundation failure | Other | R 10,000.00 |

Ref #12.4 - Significant damage to wall

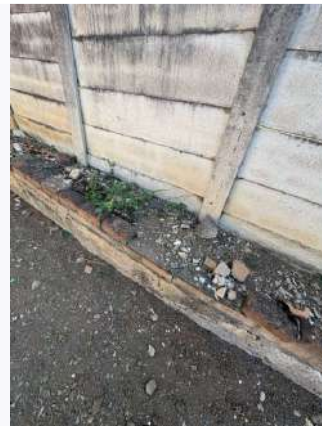
| MATERIAL DEFECTS | | | |
|---|---|---|---|
| <a href="#">12.5</a> Grounds » Garden walls | Evidence of foundation failure | Builder | R 8,000.00 |

Ref #12.5 - Damage to garden wall

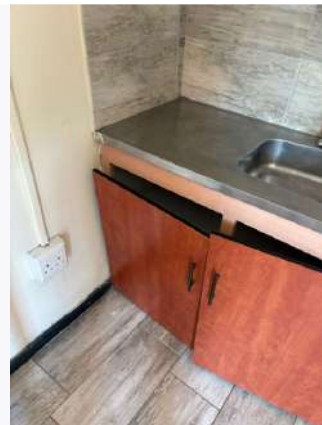
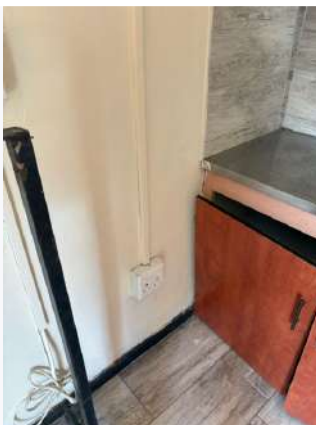
| MAINTENANCE | | | |
|---|---|---|---|
| <a href="#">13.1</a> Cottage/External building »<br>Kitchen | Cupboards doors damaged | Carpenter | R 1,000.00 |

Ref #13.1 - Damaged doors

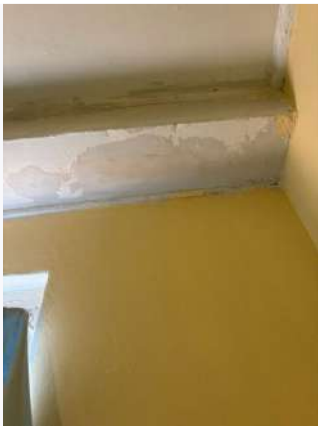
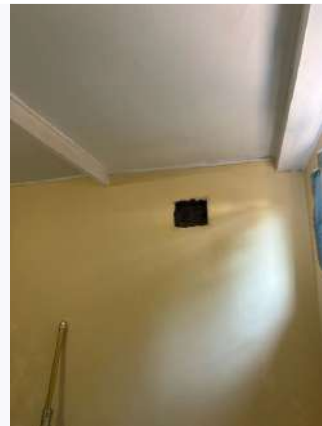
| MATERIAL DEFECTS | | | |
|---|---|---|---|
| <a href="#">13.2</a> Cottage/External building » Bedroom | -Mold observed on some sections of the walls . The location of the mold suggests an issue of rising damp as detailed in the grounds section of this report.<br>- Significant damage to the ceiling structure, this is possibly due to a leaking roof . | Painter | R 5,000.00 |

Ref #13.2 - Damaged ceiling

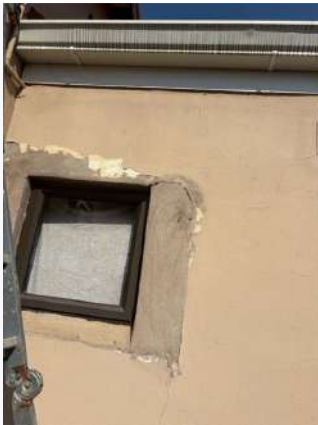
| 13.3 | Superstructure | Planted and painted | <p>Major cracks on walls</p> <p><b>MATERIAL DEFECTS - Builder</b></p> | Repairs recommended |

Ref #13.3 - Crack in wall

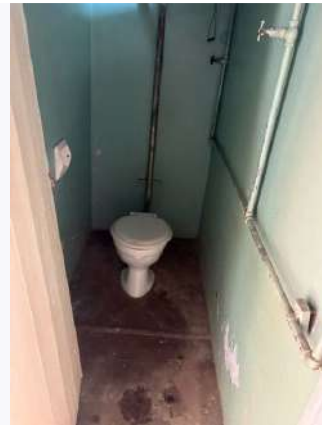
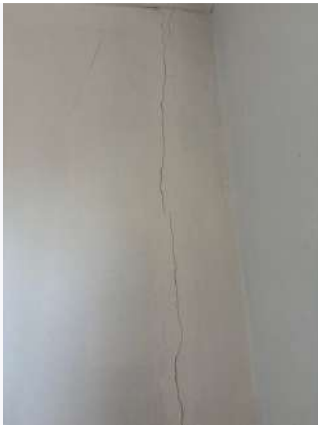
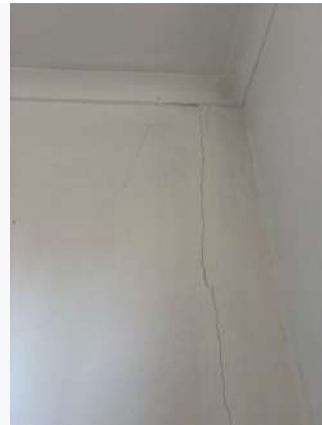
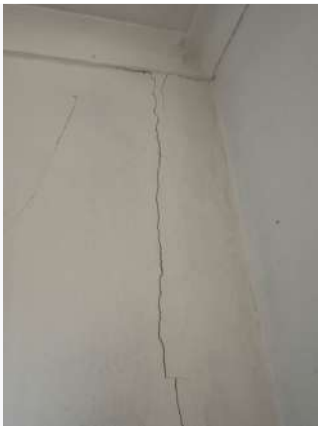
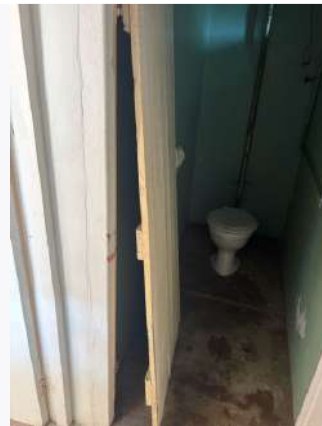
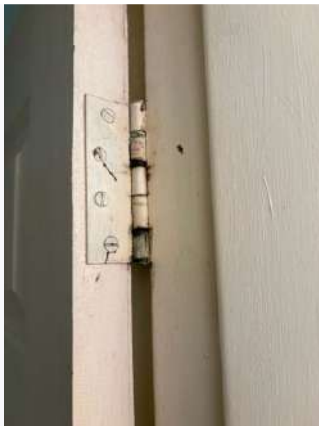
| 13.4 | Bathroom | Plastered and painted | <p>-Cracks were observed in bathroom wall, the crack were measured to be less than 4mm and requires redecorating</p> <p>-,Mold was observed in the bathroom wall , this is due to rising damp as detailed in the grounds section of the report.</p> <p>- Damaged bathroom door observed.</p> <p><b>MAINTENANCE - Painter</b> <b>MATERIAL DEFECTS - Carpenter</b></p> | |

Ref #13.4 - Mold/paint flaking

Ref #13.4 - Cracks in walls

Ref #13.4 - Damaged door
