### Property Condition Report: Introduction

The HouseCheck Property Condition Report is designed for property owners and prospective buyers seeking a comprehensive assessment of defects identified by the HouseCheck inspector. This report encompasses both "Material Defects" and "Minor or Cosmetic imperfections" that require attention to restore the property to its optimal state. With reference to compliance under South Africa's National Building Regulations and the South African National Standards (SANS) 10400.

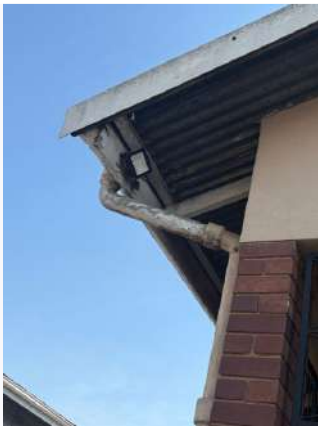
| 7. ROOF EXTERIORS | | | | MAIN STRUCTURE |
|---|---|---|---|---|
| 7.4 | Gutters & Downpipes | Asbestos downpipes<br>asbestos gutters<br>,PVC Gutters | 1. Some downpipes were discharging on unprotected soil at the base of a wall .<br>2.Gutter system infested with debris<br>MAINTENANCE - Handyman | Maintenance recommended,<br>Repairs recommended |

*Ref #7.4 - Gutter gutter system infested with debris*

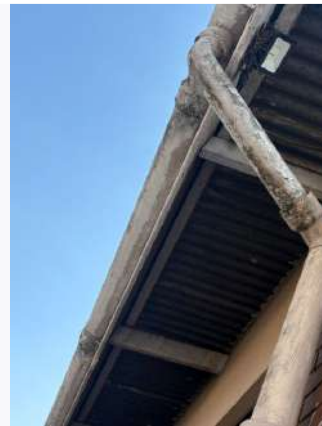
*Ref #7.4 - Gutter gutter system infested with debris*

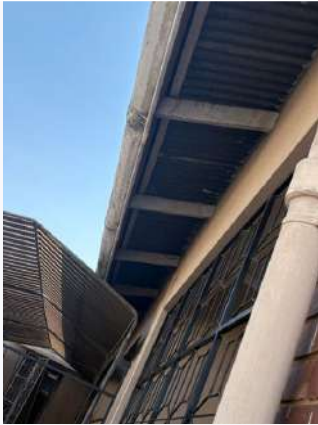
Ref #7.4 - Gutter system infested with debris

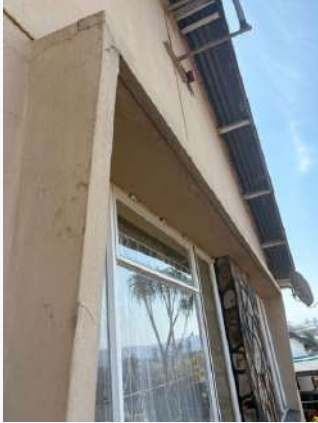
Ref #11.2 - Mold on wall

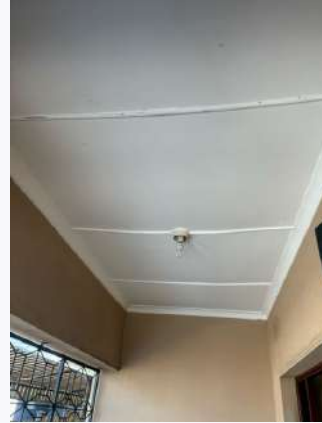
Ref #11.4 - Sagging ceiling

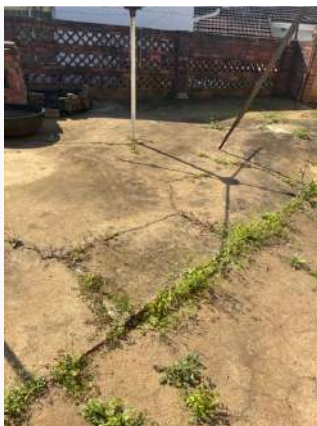
Ref #12.1 - Evidence of water ponding/Ground subsiding

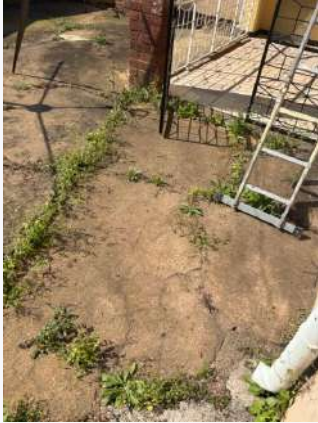
Ref #12.1 - Evidence of water ponding/Ground subsiding

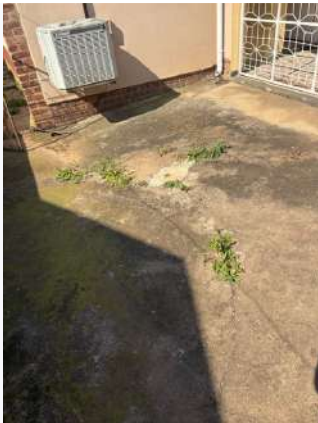
Ref #12.1 - Evidence of water ponding/Ground subsiding

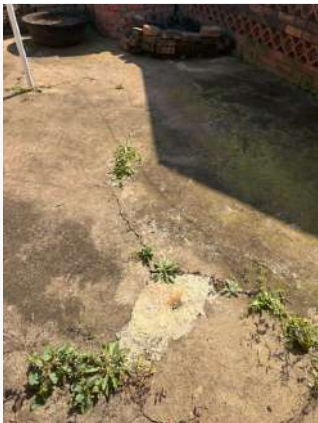
Ref #12.1 - Evidence of water ponding/Ground subsiding

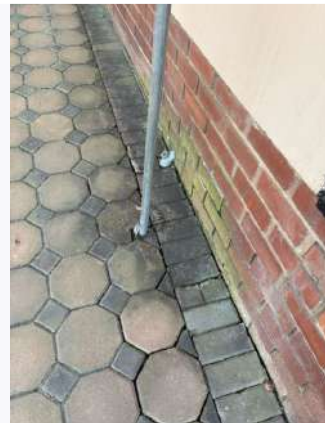
Ref #12.3 - Paving subsided

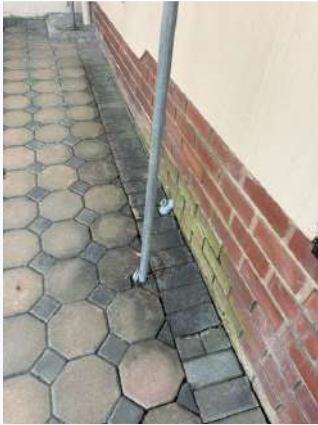
Ref #12.3 - Paving subsided

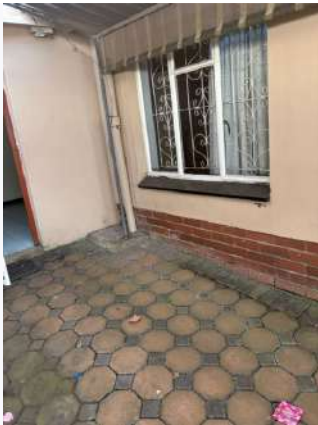
Ref #12.3 - Paving subsided

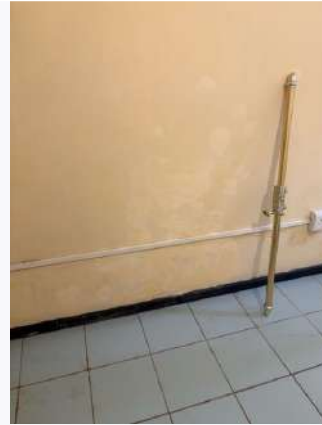
Ref #13.2 - Mold on wall

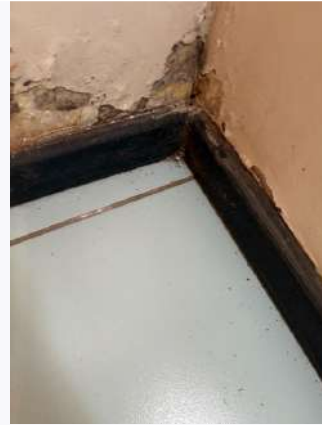
Ref #13.2 - Mold on wall

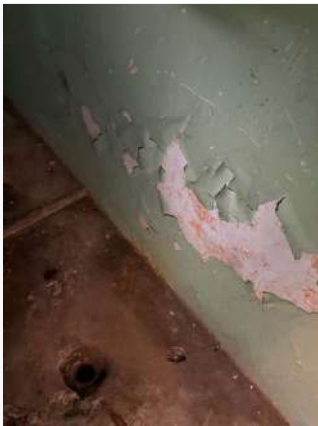
| 13.4 | Bathroom | Plastered and painted | <p>-Cracks were observed in bathroom wall, the crack were measured to be less than 4mm and requires redecorating</p> <p>-,Mold was observed in the bathroom wall , this is due to rising damp as detailed in the grounds section of the report.</p> <p>- Damaged bathroom door observed.</p> <p><b>MAINTENANCE - Painter</b> <b>MATERIAL DEFECTS - Carpenter</b></p> | |

Ref #13.4 - Mold/paint flaking
